**Federal Aviation
Administration**

ADVISORY CIRCULAR

AVIATION MAINTENANCE ALERTS

**ALERT
NUMBER
374**

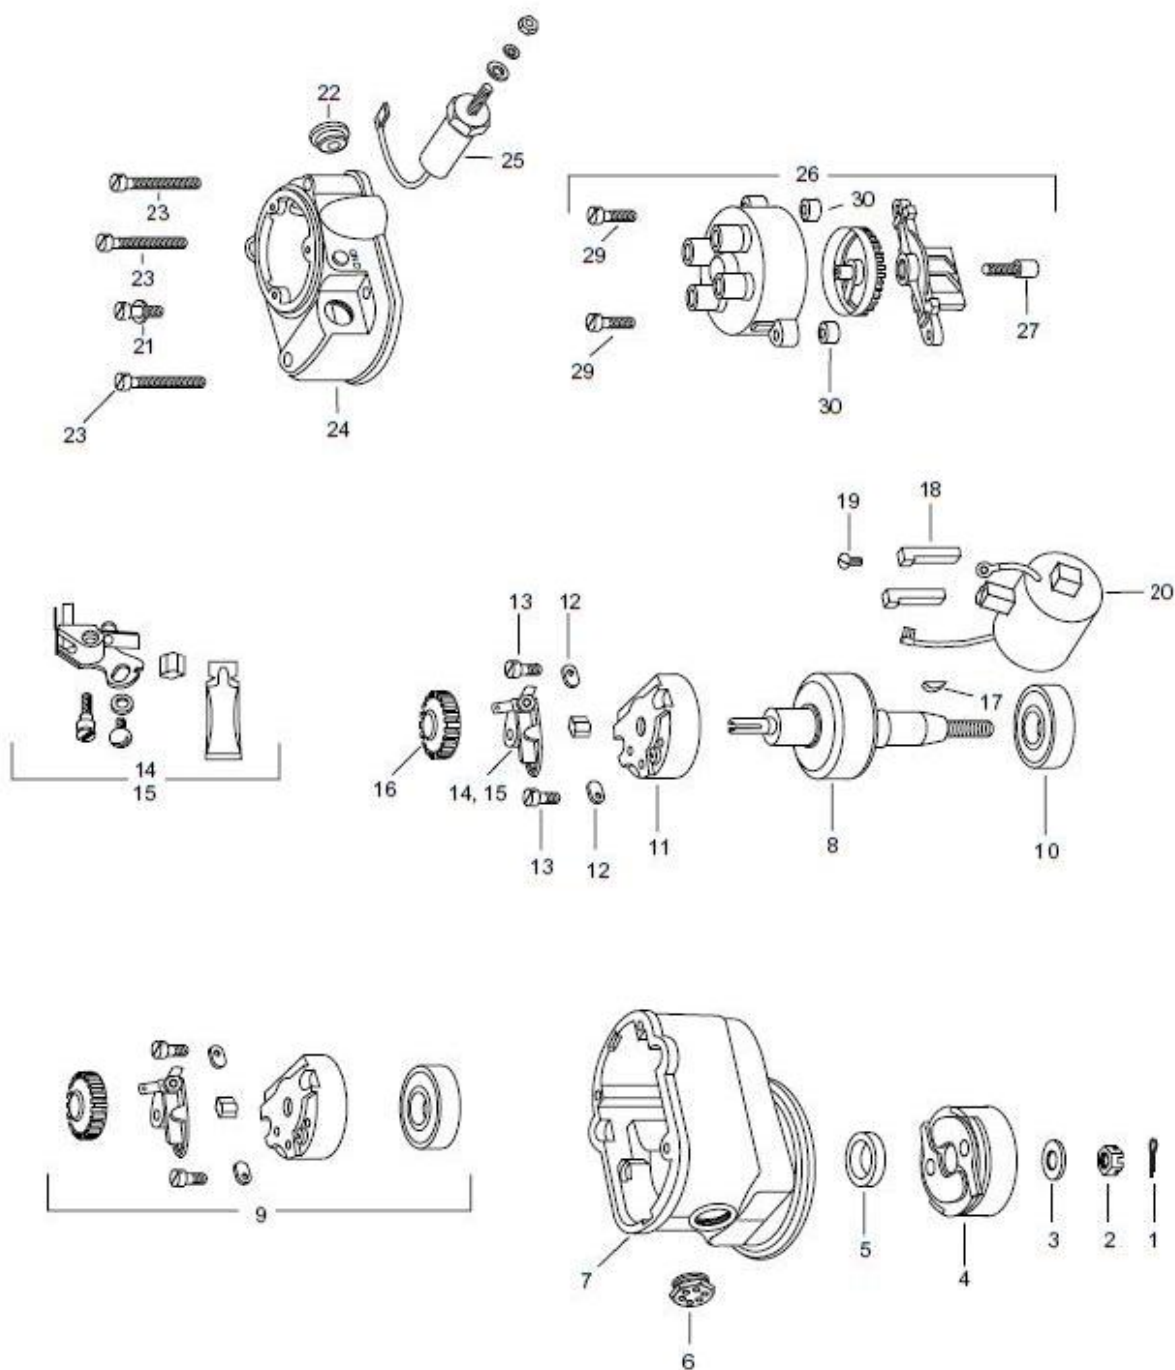
"The aircraft had intermittent magneto operation on the left magneto position during the ground run-up procedure. Aircraft maintenance was able to duplicate this problem, (*effecting*) removal of the magneto for internal inspection. Rotor (#16) was unseated from the rotor shaft, causing the lip on the rotor gear to be ground-up by the distributor block gear. The lip material was found throughout the inside of the magneto housing. Aircraft maintenance removed the right magneto for visual inspection and found the same damage as the left magneto. Both magnetos had factory torque seal applied to the top cover screws."

Rotor gears were found up on shaft
